**Flood Control Project Maintenance
Levee Inspections**

Fall 2014 Levee Maintenance Deficiency Summary Report

Sacramento River Basin

Sutter Maintenance Yard East-West Interceptor

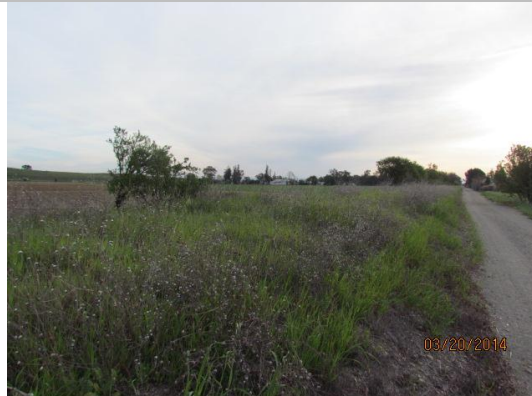
Photo 1 of 1 : FA_2014_ST0020_213_7_20141013_00005.jpg

LM Start	0.00	Rating **	M	Issue No.	7
LM End	0.32	Issue Type +	Ma	Location *	WS
Category	Earthen Levee			GPS Latitude/Longitude	
				Start	End
Item	Vegetation			39.171577 °	39.171481 °
				-121.760019 °	-121.754826 °
DWR ID	DWR_NA0020_01_s_2012_7				
Action/Comments					
Remove the wild growth other than native grasses from the levee slopes.

View of the vegetation along the w/s toe.

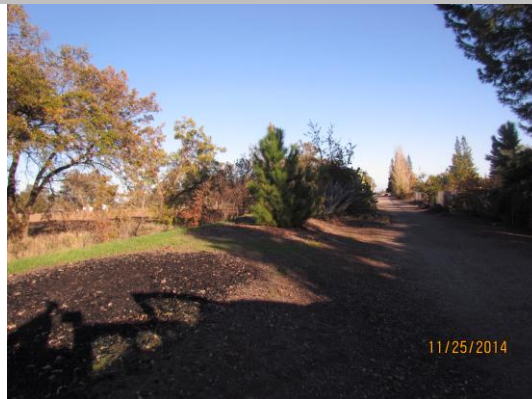
Photo 1 of 1 : FA_2014_ST0020_213_2_20141201_00012.jpg

LM Start	0.23	Rating **	M	Issue No.	2
LM End	0.25	Issue Type +	En	Location *	CR
Category	Earthen Levee			GPS Latitude/Longitude	
				Start	End
Item	Vegetation			39.171418 °	39.171408 °
				-121.755963 °	-121.755578 °
DWR ID	DWR_NA0020_01_s_2012_2				
Action/Comments					
Landscaping

View of the cactus and pine trees along the waterside berm.

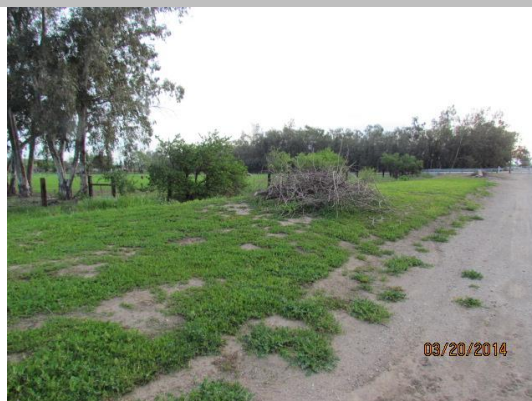
Photo 1 of 1 : FA_2014_ST0020_213_23_20141013_00010.jpg

LM Start	0.36	Rating **	M	Issue No.	23
LM End	0.36	Issue Type +	En	Location *	CR
Category	Earthen Levee			GPS Latitude/Longitude	
				Start	End
Item	Encroachments			39.171450 °	39.171450 °
				-121.754058 °	-121.754058 °
DWR ID	DWR_NA0020_01_f_2013_23				
Action/Comments					
Prunings

View of the tree limbs and debris on the w/s berm.

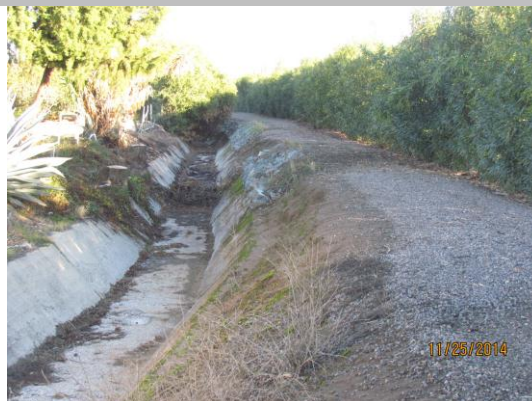
Photo 1 of 1 : FA_2014_ST0020_213_4_20141201_00013.jpg

LM Start	0.62	Rating **	U	Issue No.	4
LM End	0.65	Issue Type +	Ma	Location *	WS
Category	Earthen Levee			GPS Latitude/Longitude	
				Start	End
Item	Erosion / Bank Caving			39.171292 °	39.171232 °
				-121.748868 °	-121.748175 °
DWR ID	DWR_NA0020_01_s_2012_4				
Action/Comments					
Schedule repair of erosion site prior to the next inspection.

View of the erosion along the concrete ditch on the waterside slope.

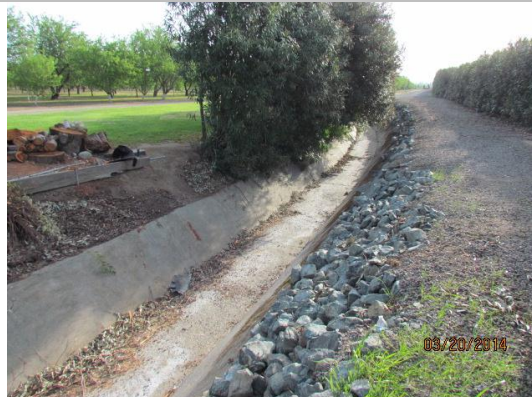
Photo 1 of 1 : FA_2014_ST0020_213_102_20141013_00011.jpg

LM Start	0.63	Rating **	A	Issue No.	102
LM End	0.63	Issue Type +	Ma	Location *	WS
Category	Earthen Levee			GPS Latitude/Longitude	
				Start	End
Item	Erosion / Bank Caving			39.171329 °	39.171329 °
				-121.748235 °	-121.748235 °
DWR ID	DWR_ST0020_01_s _ 2014_102				
Action/Comments					
Note and monitor erosion site.

View of the repaired erosion along the w/s ditch.

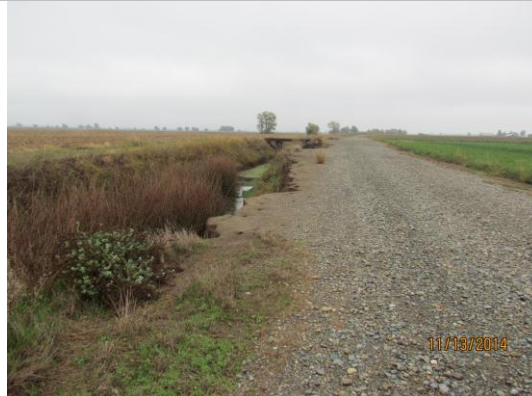
Photo 1 of 1 : FA_2014_ST0020_213_6_20141201_00020.jpg

LM Start	1.67	Rating **	U	Issue No.	6
LM End	1.67	Issue Type +	Ma	Location *	WS
Category	Rivers, Channels & Designated Floodways			GPS Latitude/Longitude	
				Start	End
Item	Erosion / Bank Caving			39.171128 °	39.171128 °
				-121.729235 °	-121.729235 °
DWR ID	DWR_NA0020_01_s_2012_6				
Action/Comments					
Inspector Comments: Sutter Yard needs to repair the channel.

View of the erosion along the waterside slope.

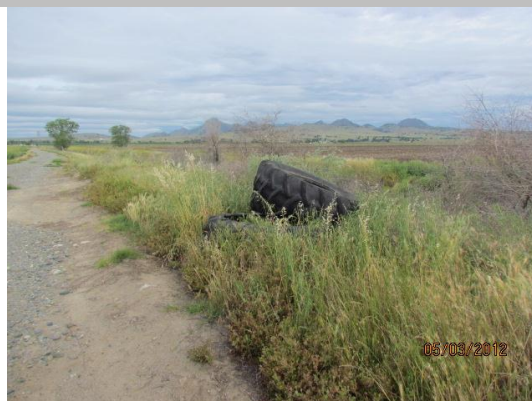
Photo 1 of 1 : FA_2014_ST0020_214_12_20141013_00008.jpg

LM Start	0.25	Rating **	M	Issue No.	12
LM End	0.25	Issue Type +	En	Location *	WS
Category	Earthen Levee			GPS Latitude/Longitude	
				Start	End
Item	Encroachments			39.171107 °	39.171107 °
				-121.722069 °	-121.722069 °
DWR ID	DWR_NA0020_02_s_2012_12				
Action/Comments					
Garbage Inspector Comments: Tires

View of the tires along the W/S toe.

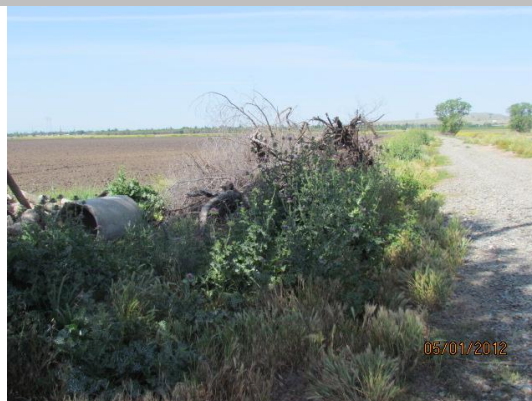
Photo 1 of 1 : FA_2014_ST0020_214_9_20141013_00006.jpg

LM Start	0.26	Rating **	M	Issue No.	9
LM End	0.26	Issue Type +	En	Location *	LS
Category	Earthen Levee			GPS Latitude/Longitude	
				Start	End
Item	Encroachments			39.171101 °	39.171101 °
				-121.721856 °	-121.721856 °
DWR ID	DWR_NA0020_02_s_2012_9				
Action/Comments					
Debris

View of the debris along the L/S toe.

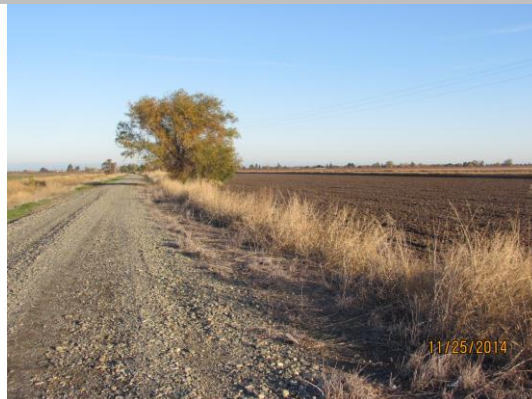
Photo 1 of 1 : FA_2014_ST0020_214_2_20141201_00014.jpg

View of the vegetation on both slopes.

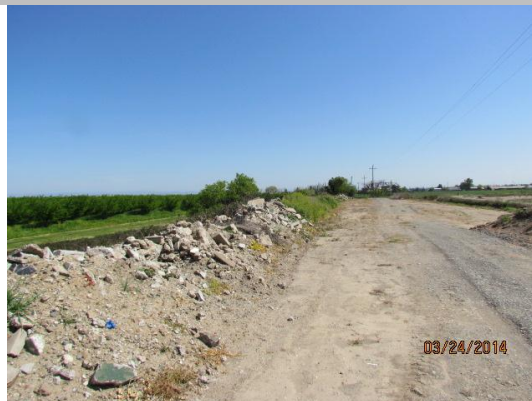
Photo 1 of 1 : FA_2014_ST0020_214_3_20141013_00002.jpg

View of the piles of broken concrete next to the levee.

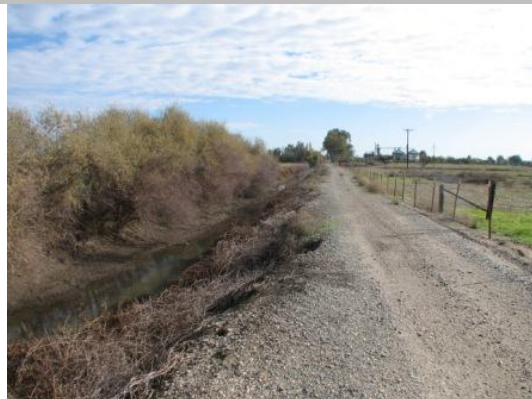
Photo 1 of 1 : FA_2014_ST0020_214_4_20141013_00003.jpg

View of the erosion along the waterside slope.

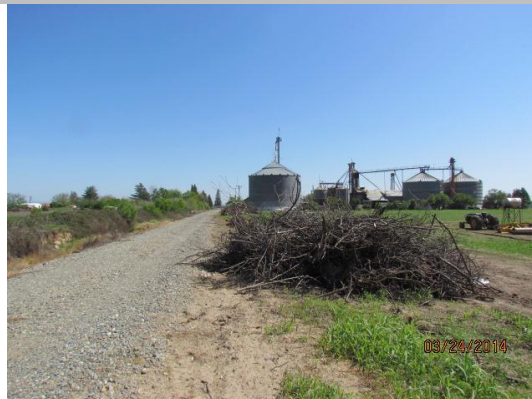
Photo 1 of 1 : FA_2014_ST0020_214_25_20141013_00011.jpg

LM Start	1.82	Rating **	M	Issue No.	25
LM End	1.89	Issue Type +	En	Location *	LS
Category	Earthen Levee			GPS Latitude/Longitude	
				Start	End
Item	Encroachments			39.170801 °	39.170794 °
				-121.692591 °	-121.691355 °
DWR ID	DWR_ST0020_02_s_ 2014_25				
Action/Comments					
Prunings

View of the tree prunings along the landside slope.

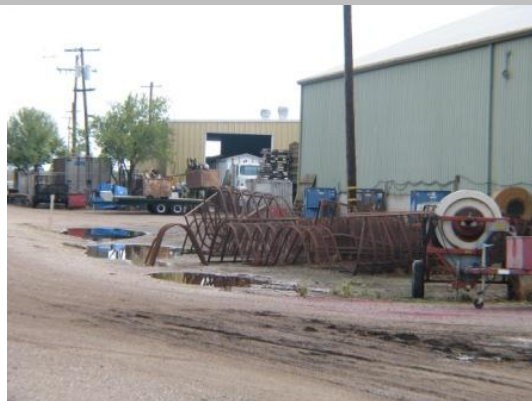
Photo 1 of 1 : FA_2014_ST0020_214_5_20141013_00004.jpg

LM Start	1.92	Rating **	M	Issue No.	5
LM End	2.04	Issue Type +	Ma	Location *	LS
Category	Earthen Levee			GPS Latitude/Longitude	
				Start	End
Item	Encroachments			39.171104 °	39.171104 °
				-121.718880 °	-121.718876 °
DWR ID	DWR_NA0020_02_s_2012_5				
Action/Comments					
Equipment

View of the equipment and buildings next to the landside berm.

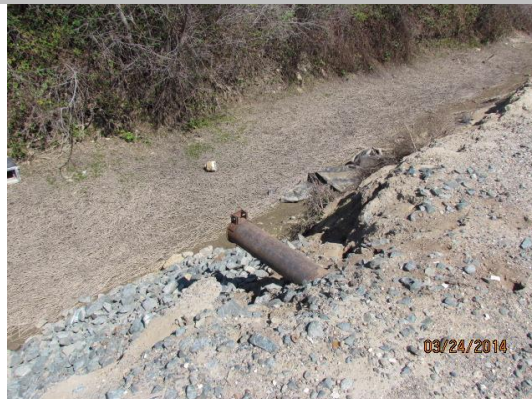
Photo 1 of 1 : FA_2014_ST0020_214_26_20141013_00012.jpg

LM Start	1.93	Rating **	U	Issue No.	26
LM End	1.93	Issue Type +	En	Location *	CR
Category	Earthen Levee			GPS Latitude/Longitude	
				Start	End
Item	Encroachments			39.170743 °	39.170743 °
				-121.690644 °	-121.690644 °
DWR ID	DWR_ST0020_02_s_ 2014_26				
Action/Comments					
Pipe

View of the unauthorized pipe going through the crown of the levee.

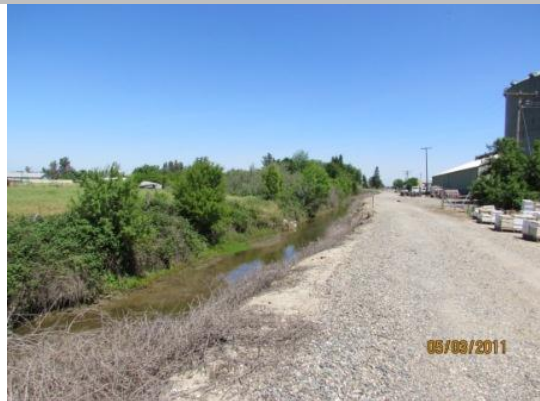
Photo 1 of 1 : FA_2014_ST0020_214_6_20141013_00005.jpg

View of the erosion along the W/S slope.

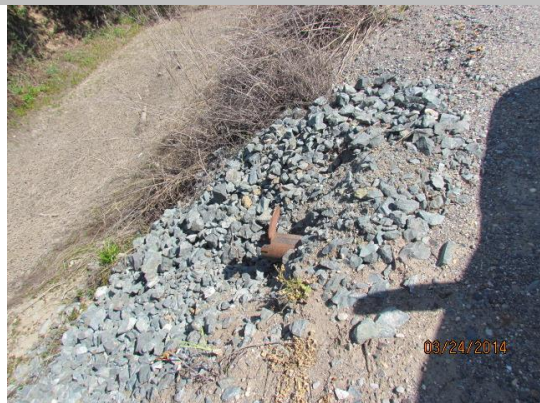
Photo 1 of 1 : FA_2014_ST0020_214_27_20141013_00013.jpg

View of the unauthorized pipe going through the crown of the levee.

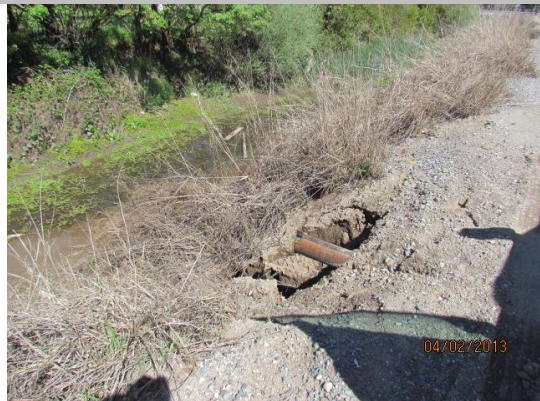
Photo 1 of 1 : FA_2014_ST0020_214_17_20141013_00009.jpg

View of the erosion caused by the unauthorized pipe.
